# **Alaska FACE**

### **Worker struck by side ring of multi-piece (split) rim during wheel installation**

**FACE 03AK006**

**Released: December 12, 2003**

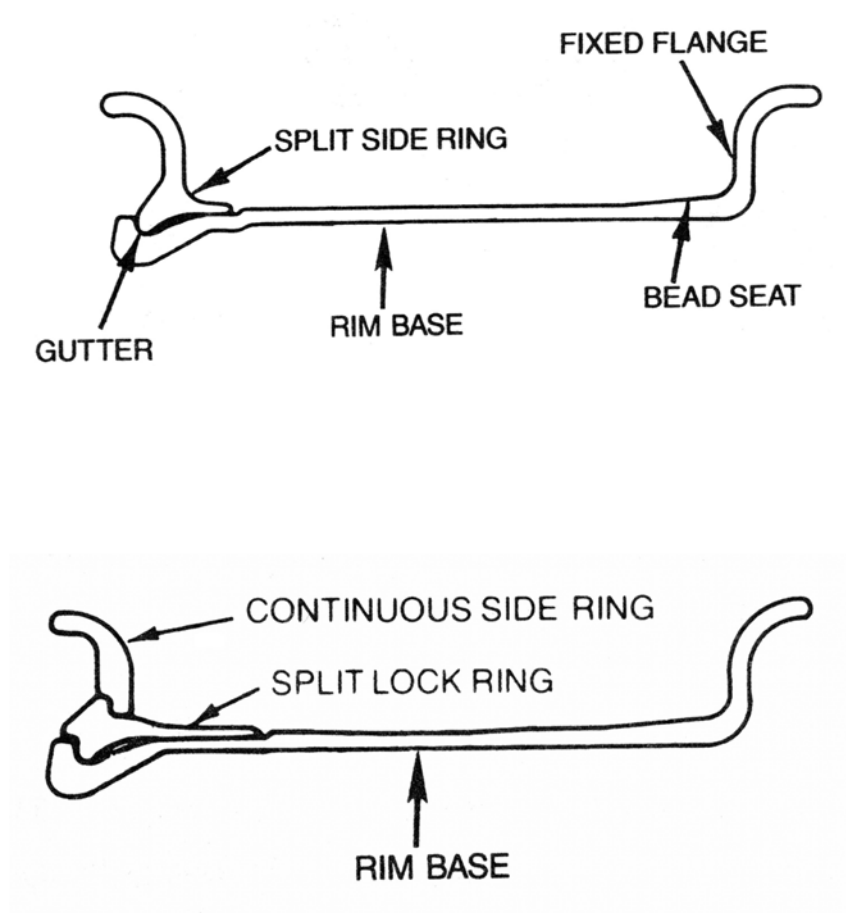
The rim wheel in this incident was a tube-type tire on a demountable rim (multi-piece). This rim had three pieces consisting of a rim base, a split locking ring, and a continuous side ring or flange (Figure 1). The parts are designed to allow the split locking ring to fit into a gutter on the base rim, "locking" the flange in place on the rim when the tire is inflated.

**Figure 1. Parts of a demountable two- and three-piece rim**

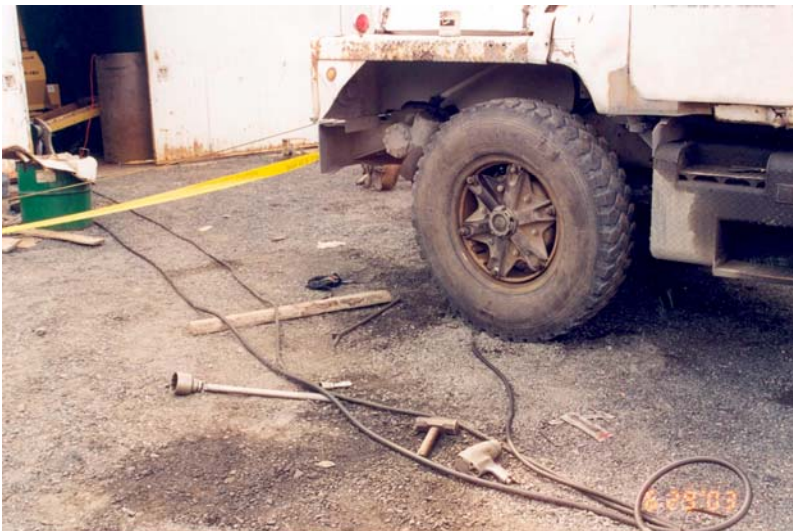
a hub and six spokes (Figure 2). Each manufacturer details a bolt pattern to be used to install the wheel, usually in a cross-cross pattern to allow the rim to set evenly against the wheel.

**Figure 2. View of wheel assembly**
